INDOOR AIR QUALITY ASSESSMENT

**State Transportation Building
Suite 4150 and other rooms on the 4th and 2nd floor
10 Park Plaza
Boston, MA**

Prepared by:
Massachusetts Department of Public Health
Bureau of Environmental Health
Indoor Air Quality Program
September 2018

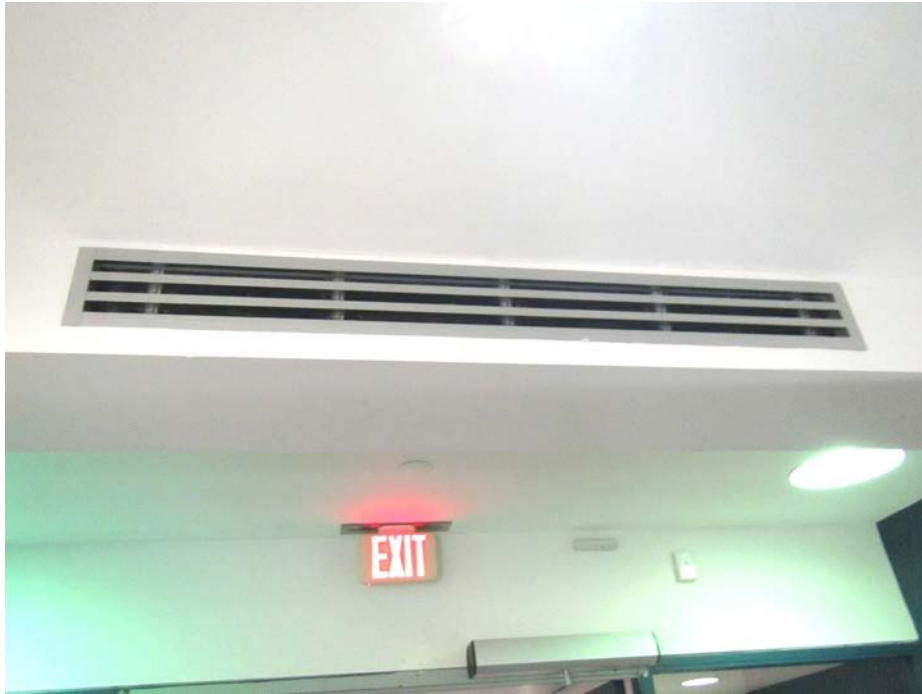
Picture 1

In the reception area in suite 4160, the occupant had complaints regarding drafts from the ventilation system. The location of the reception desk is directly in the path of the vents along the top part of the walls (Picture 1) and is a large space that requires fresh air distribution. It may be possible to install baffles on these vents to redirect air such that it is not blowing directly on the reception desk. In addition, regular cleaning of supply and return vents should be conducted to prevent a built up of dust that can be reaerosolized or become a medium for mold growth.

Supply vent in 4160 reception area

5. Remove items from the top and front of vent cabinets to allow for air flow.
6. Consider adding baffles or changing the vent configuration in the reception area in suite 4160 to reduce drafts.

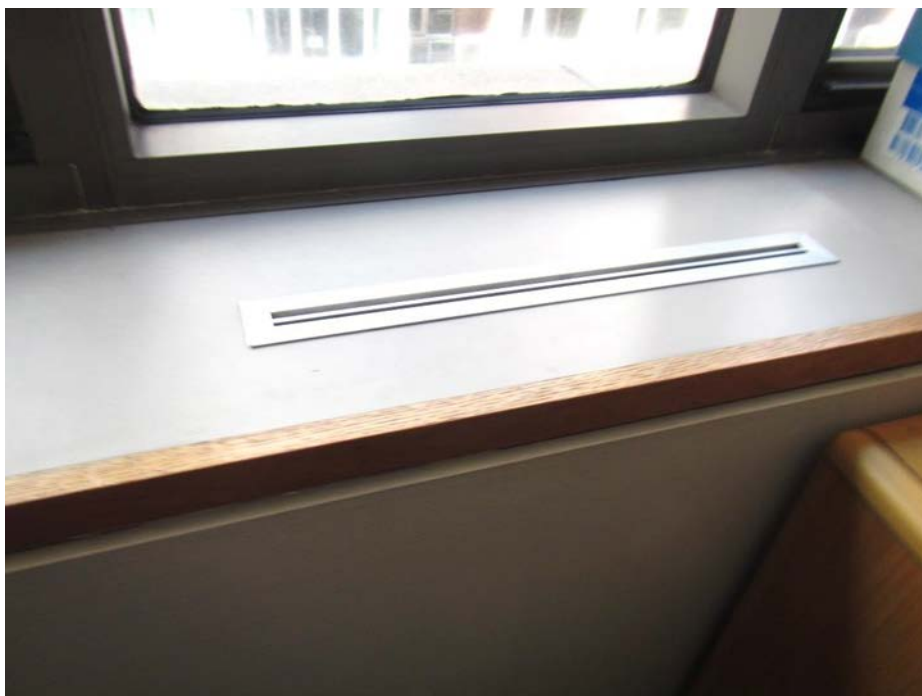
Picture 2

Fresh air is supplied by vents located in the ceiling, the upper portions of walls (Picture 1), or from units near windows (Picture 2). Return air is drawn through vents around light fixtures using ducted returns (Picture 3). Some rooms on the second floor had supplemental heaters built into the walls (Picture 4). In some areas, items were on the vent cabinets, including plants (Picture 5). This can block the supply of fresh air as well as aerosolize odors and particulates such as dust, mold spores, and pollen. Vents should be kept clear of items.

Cabinet-unit supply

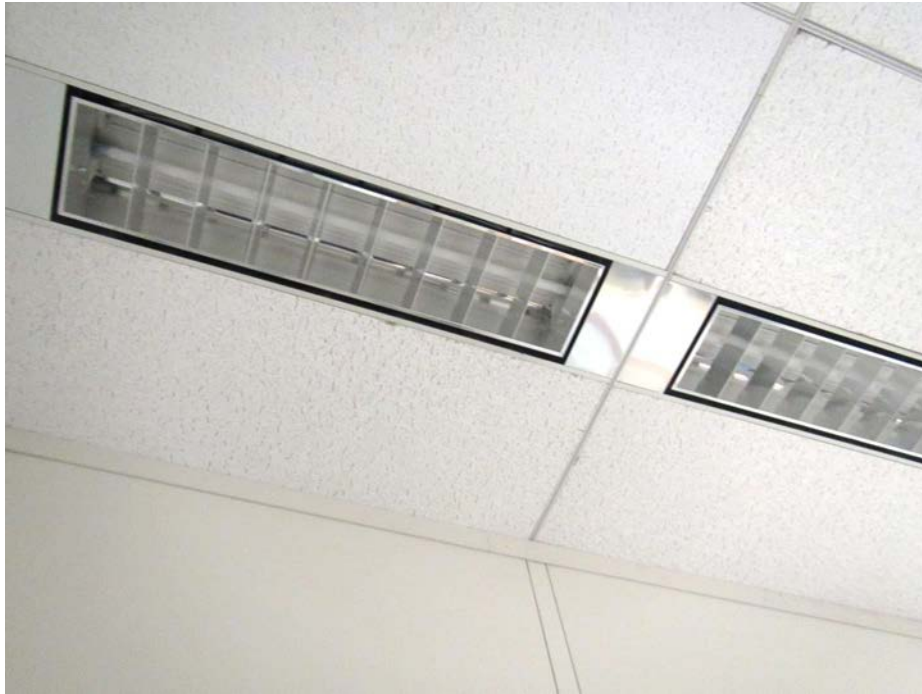
Picture 3

Return vents around light fixtures

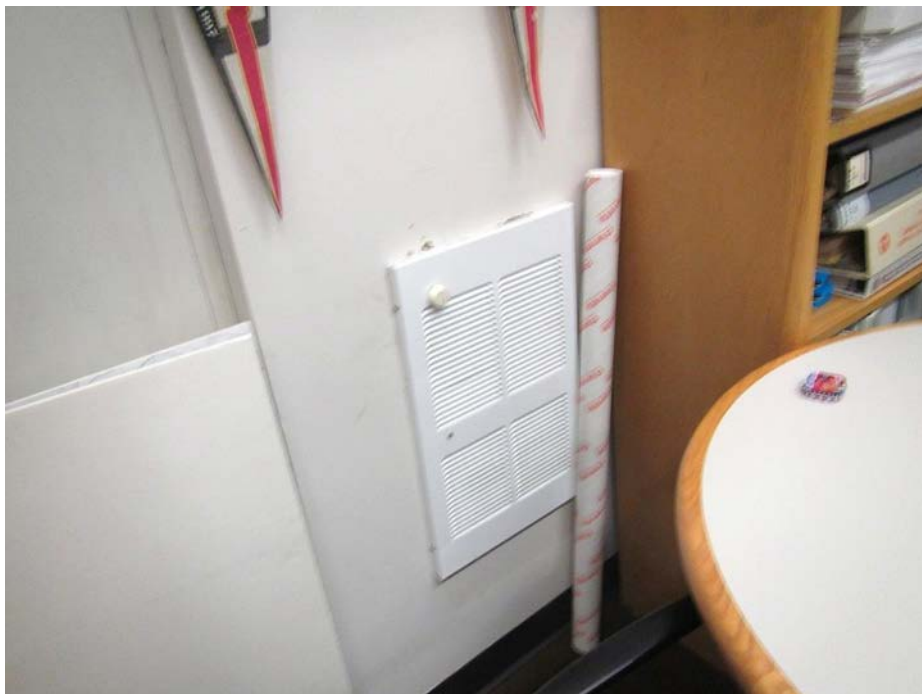
Picture 4

Heater built into wall

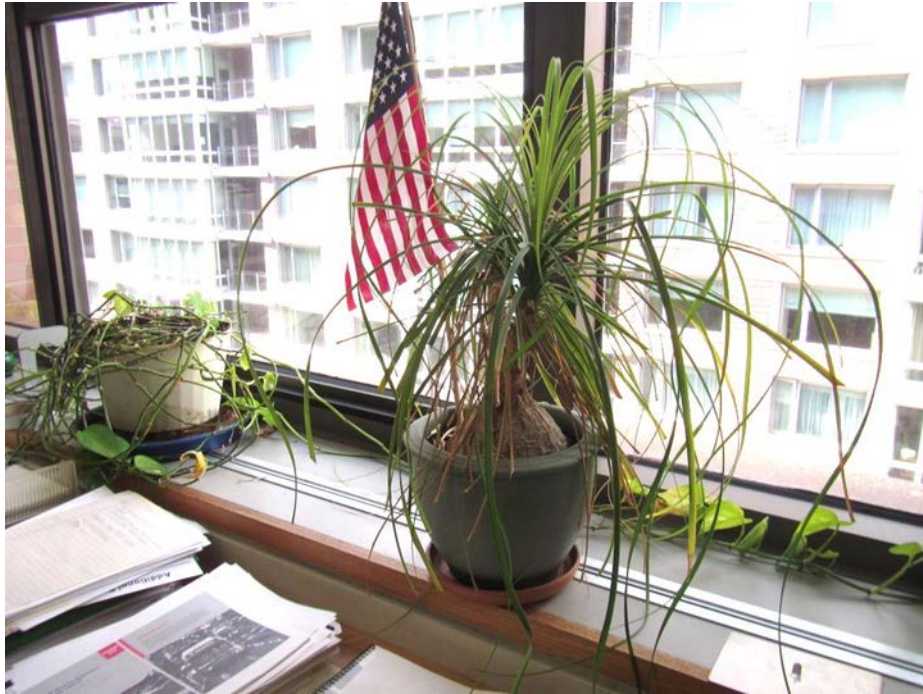
Picture 5

Plants were noted in a few areas (Table 1; Picture 5). Cut flowers in water were also noted (Table 1). Plants/flowers can be a source of pollen and mold, which can be respiratory irritants to some individuals. Plants should be properly maintained and equipped with drip pans and should be located away from airflow to prevent the aerosolization of dirt, pollen, and mold.

Plants on vent

9. Replace water-damaged ceiling tiles. Repair any source of leaks as they are discovered.
10. Keep plants and flowers in good condition, avoid overwatering, and remove from the airstream of heating and ventilation equipment.

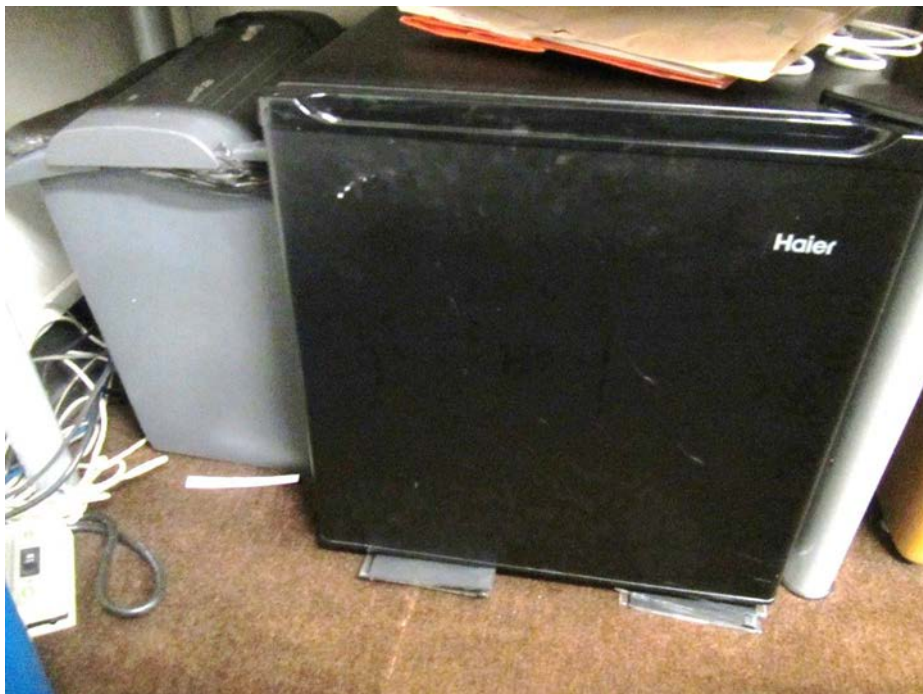
Picture 6

Water damage and musty/moldy odors were a concern in some areas examined. Room 2161 had been left closed to concentrate any odors, and a slight musty odor was detected on entry. No direct source of the odor could be found. Two potential sources include worn and

degraded carpeting that had a small refrigerator on it (Picture 6) which may have been subject to spills and paper/books on shelving and surfaces that may have become wet in the past. The ceiling plenum could not be accessed for assessment of odor. The ceiling plenum should be inspected by building maintenance staff to determine if any water-damaged materials such as insulation are present. The built-in heater (Picture 4) should also be maintained and cleaned. A similar odor was also reported in nearby room 2174, however this room was occupied, the door was open, and no odor was noticeable at the time of the visit. Also note that the carbon dioxide readings in these two offices were higher than most other areas tested in the building, and above the recommended value of 800 ppm, even though room 2161 was unoccupied. This suggests there may be insufficient air circulation to these offices. Increasing fresh air may reduce odors and improve perception of IAQ in these offices.

Small refrigerator on worn carpeting

8. Have the carpeting in rooms 2161 and 2174 cleaned, including moving furniture. Ensure carpeting is completely dry before replacing furniture. Examine items in both rooms for water damage and odors and discard any found to be water-damaged.

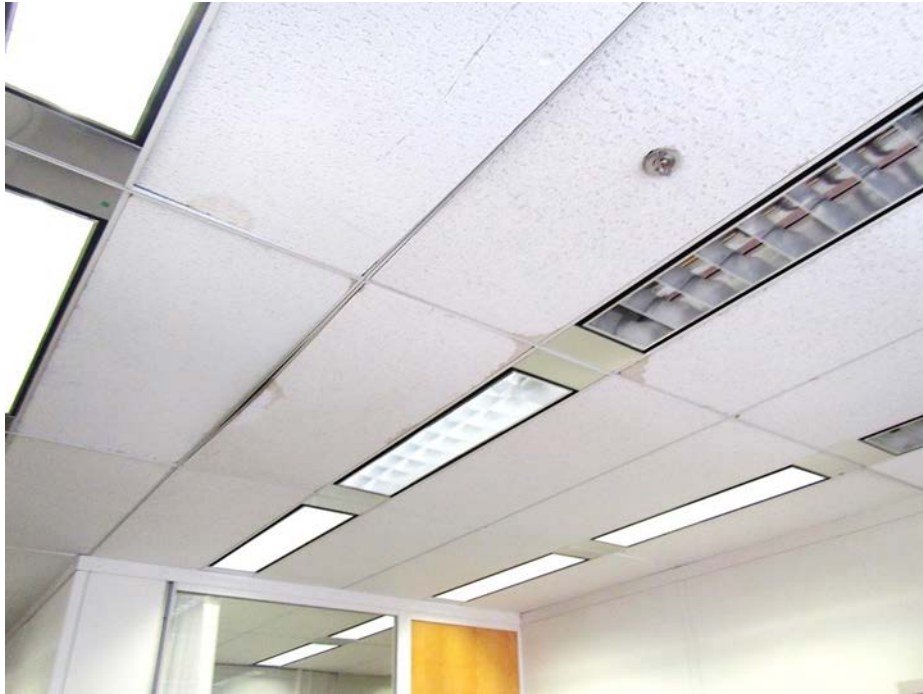
Picture 7

The plotter area in suite 4150 had several water-damaged ceiling tiles and other ceiling tiles bowed from moisture exposure (Picture 7). This area reportedly had a water leak from the roof in the past. The carpet was dry at the time of the visit, and no musty odors were detected. Another area in the suite had reportedly been subject to a leak from the HVAC or plumbing system through a structural column. This leak had reportedly been cleaned up, and no signs of water damage were noticeable during the visit. In addition, a few water-damaged ceiling tiles were observed elsewhere in the office. Water-damaged ceiling tiles should be replaced.

Water-damaged and bowed ceiling tiles in the plotter area

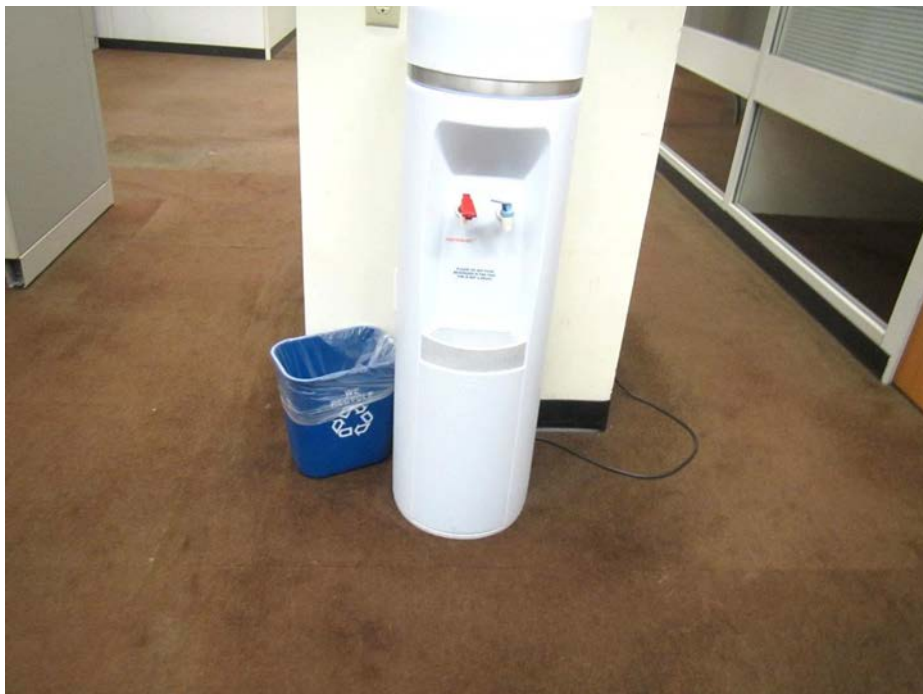
Picture 8

Refrigerators and water dispensers were located on carpet (Picture 8). Refrigerators and water dispensing equipment should be located in a non-carpeted area or on a waterproof mat to prevent damage to carpet and subsequent odors.

Water cooler on carpeting

11. Consider the use of waterproof mats underneath refrigerators and water dispensers to protect carpet from leaks and spills.
12. For buildings in New England, periods of low relative humidity during the winter are often unavoidable. Therefore, scrupulous cleaning practices should be adopted to minimize common indoor air contaminants whose irritant effects can be enhanced when the relative humidity is low. To control for dusts, a high efficiency particulate arrestance (HEPA) filter equipped vacuum cleaner in conjunction with wet wiping of all surfaces is recommended. Avoid the use of feather dusters. Drinking water during the day can help ease some symptoms associated with a dry environment (throat and sinus irritations).

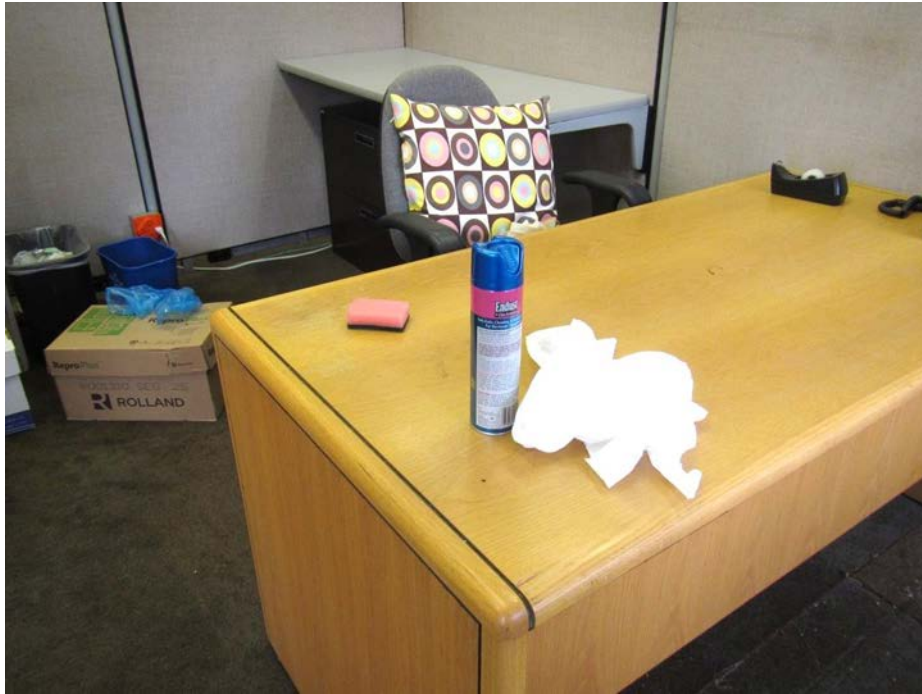
Picture 9

Exposure to low levels of total volatile organic compounds (TVOCs) may produce eye, nose, throat, and/or respiratory irritation in some sensitive individuals. BEH/IAQ staff examined spaces for products containing VOCs. BEH/IAQ staff noted air fresheners, hand sanitizers, cleaning products, and dry erase materials in the office space (Picture 9; Table 1). All of these

products have the potential to be irritants to the eyes, nose, throat, and respiratory system of sensitive individuals.

Spray cleaning product in use in the office

13. Reduce the use of cleaning products, sanitizers, and other items that contain VOCs.
14. Keep food preparation equipment clean and clean out the refrigerators, including the gaskets, regularly.

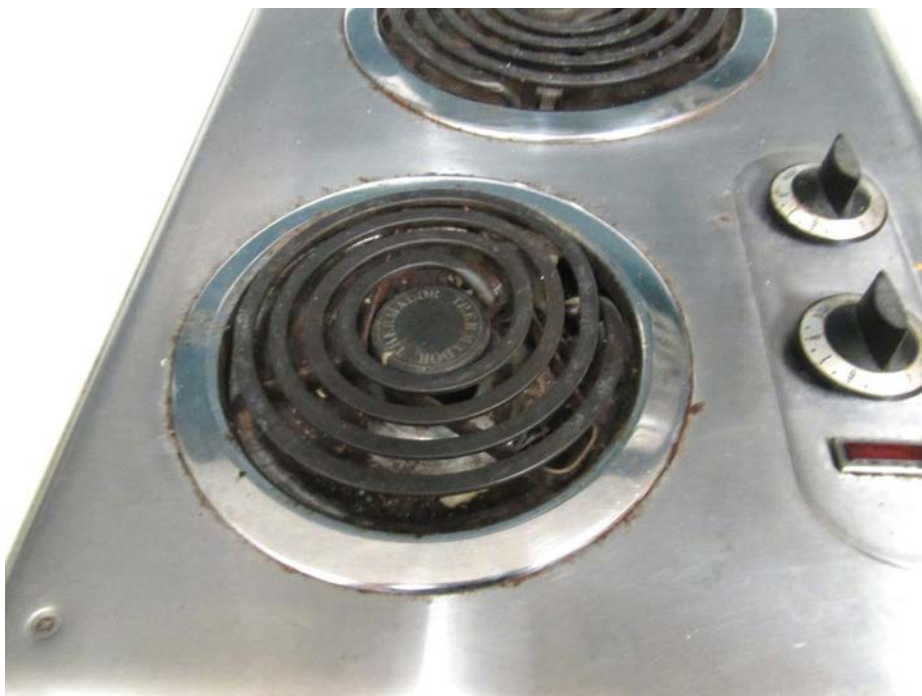
Picture 10

Food preparation equipment in the lounge in suite 4150 had food debris (Pictures 10 through 12). The refrigerator was crowded with items and the gasket needed cleaning (Picture 13). Food debris can be a source of odors, and is attractive to pests. Food preparation equipment should be cleaned regularly.

Electric cooktop with debris

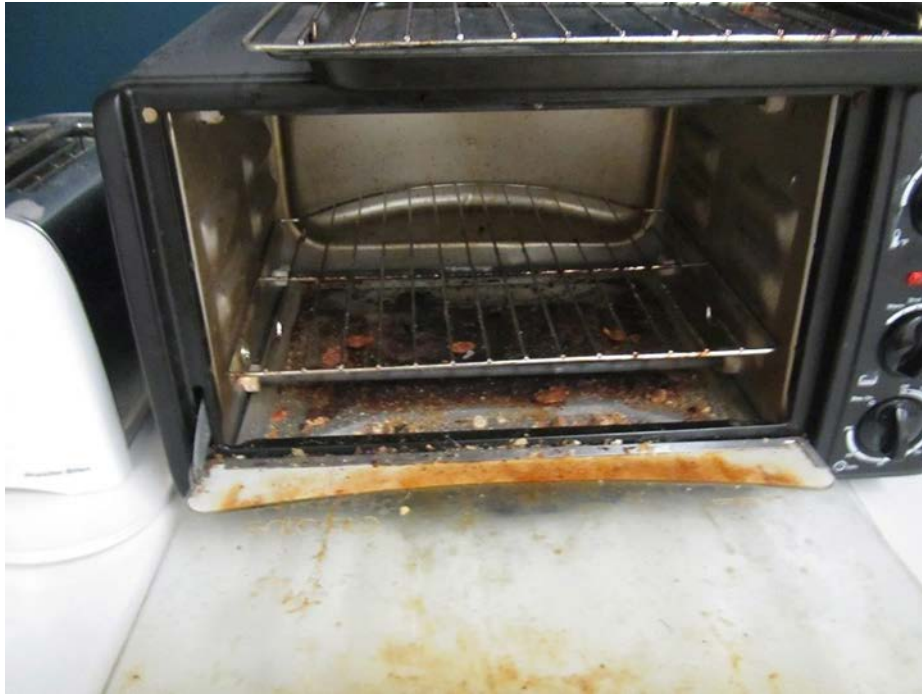
Picture 11

Debris in toaster oven

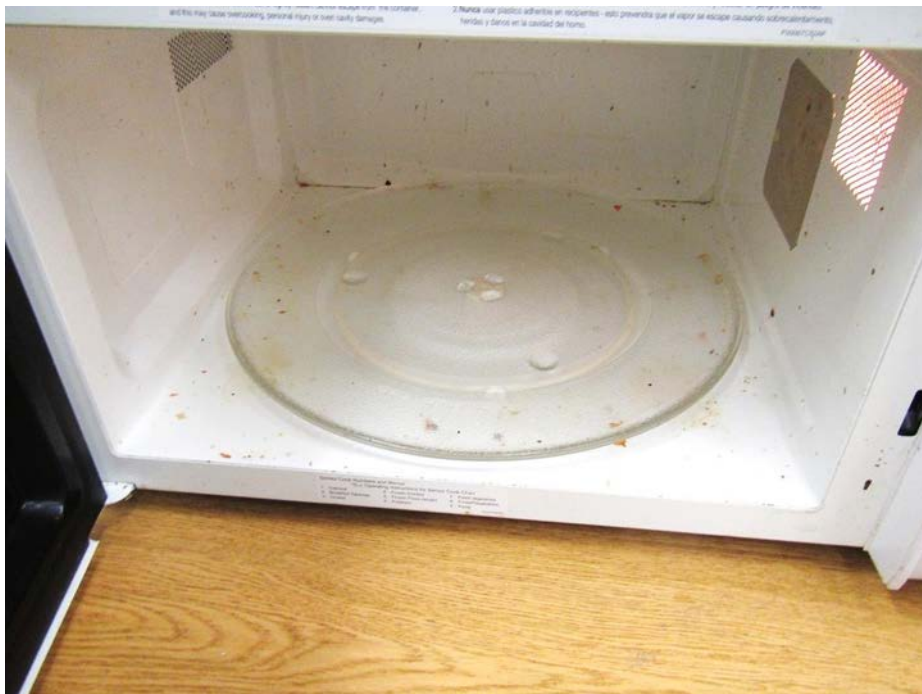
Picture 12

Debris in microwave

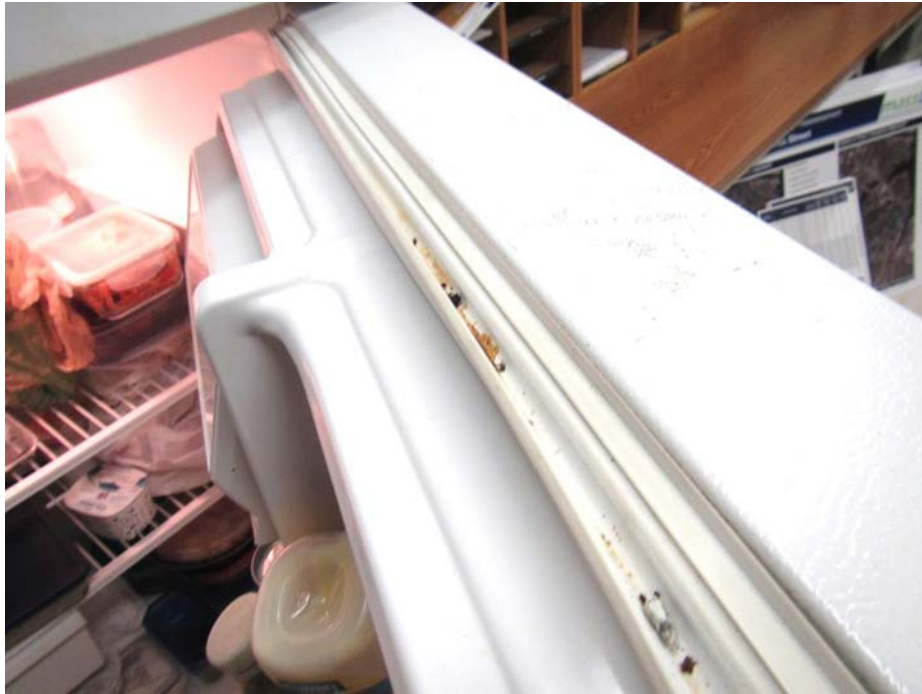
Picture 13

Debris in refrigerator gasket

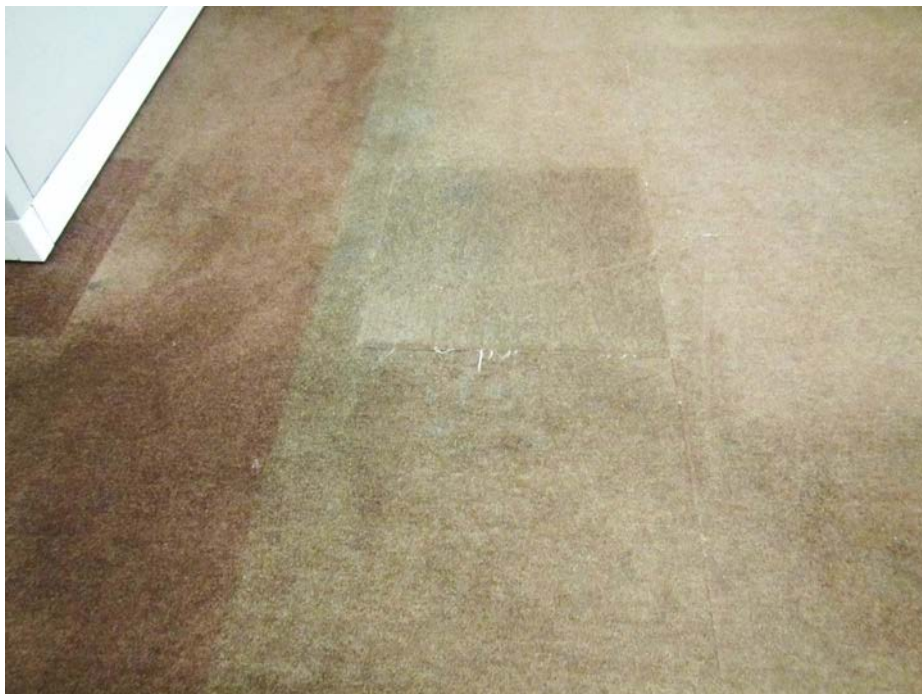
Picture 14

The offices were carpeted. In some places the carpeting is worn and damaged (Pictures 14 and 15; Table 1). Some of the carpeting examined appears to be original to the building, and thus over 30 years old. Carpeting of this age and condition often cannot be adequately cleaned and may become a source of particulates and odors. Replacement of old carpeting should be considered. Carpets should be cleaned annually (or semi-annually in soiled/high traffic areas) in accordance with Institute of Inspection, Cleaning and Restoration Certification (IICRC) recommendations, (IICRC, 2012).

Worn carpeting with patch

18. Clean carpeting in accordance with IICRC recommendations (IICRC, 2012). Consider the use of plastic chair mats under desks to protect carpeting.
19. Consider a plan to replace worn out carpeting in the building. When carpeting is replaced, carpet squares should be used to allow for easier replacement of small sections if they get damaged.
20. Refer to resource manual and other related IAQ documents located on the MDPH's website for further building-wide evaluations and advice on maintaining public buildings. These documents are available at: <http://mass.gov/dph/iaq>.

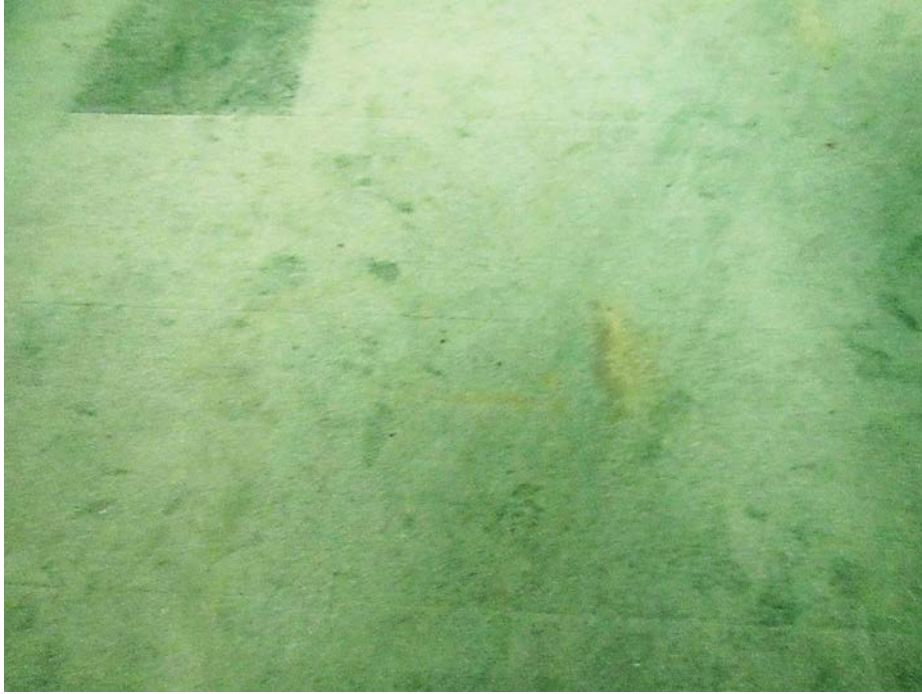
Picture 15

Soiled, worn carpeting
